Re: RED FLAG INVESTIGATION  
DES #1902785, Local Project  
Bridge Replacement Project  
Brickyard Road over Boggs Creek, 0.04 Mile North of US 50  
Martin County, Indiana

**Red Flag Investigation - Site Location**  
**Brickyard Road over Boggs Creek, 0.04 Mile North of US 50**  
**Des. No. 1902785, Bridge Project**  
**Martin County, Indiana**

**BRICKYARD ROAD OVER BOGGS CREEK  
BRIDGE REPLACEMENT  
DES. NO. 1902785  
PERRY TOWNSHIP, MARTIN COUNTY, INDIANA**

**WATERS OF THE U.S. DETERMINATION REPORT**  
**Brickyard Road over Boggs Creek**  
**Bridge Replacement**  
**Perry Township, Martin County, Indiana**  
**Des. No. 1902785**  
**Prepared By: Zachary Root, Metric Environmental, LLC**  
**February 2, 2021**

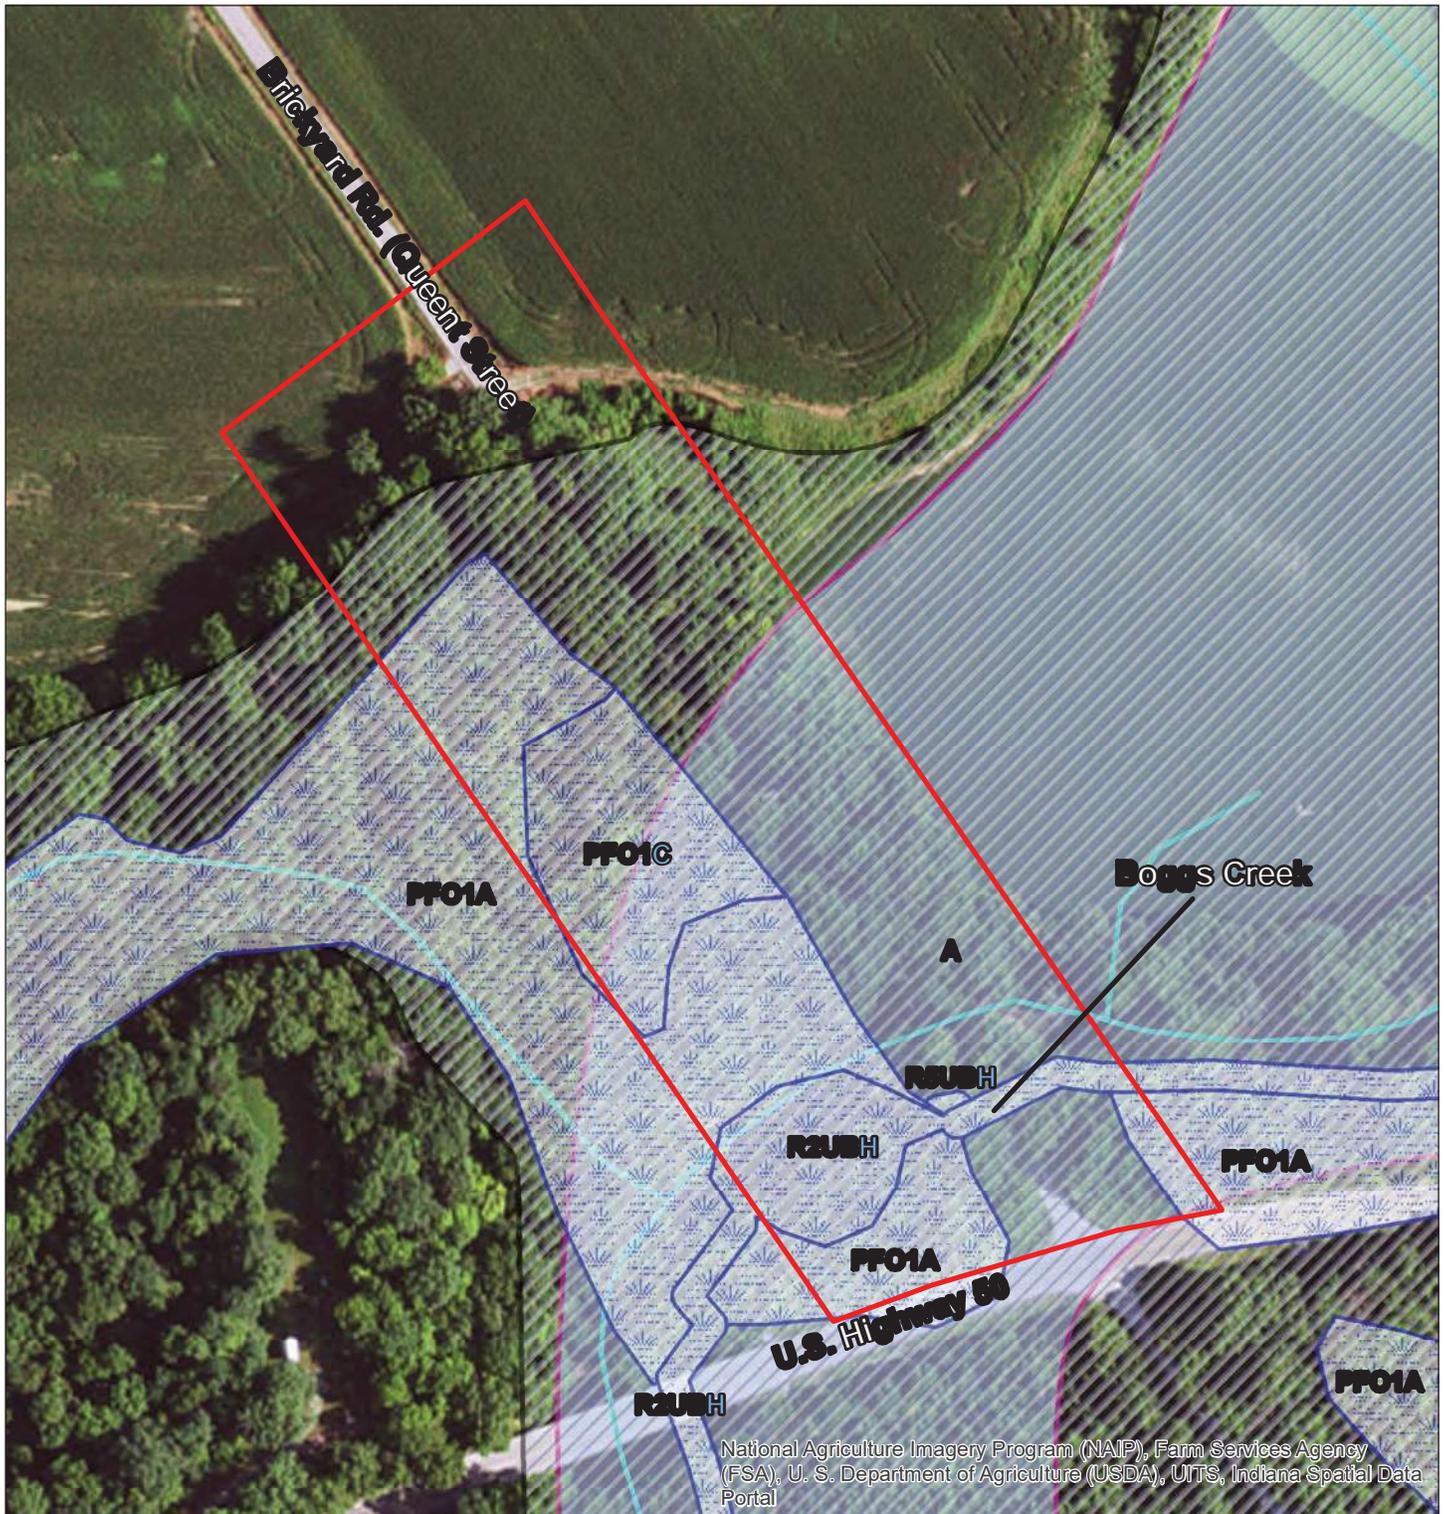
Exh. 4

Exhibit 4 - NWI, FIRM, IDNR Floodway, and NHD Flowline Map  
 Brickyard Road Over Boggs Creek  
 Bridge Replacement  
 Perry Township, Martin County, Indiana  
 Des. No. 1902785  
 Metric Project No. 20-0077  
 Map Date: 10/2/2020  
 Map Author: Zachary Root

NWI Wetlands: Forty-four (44) NWI wetlands are located within the 0.5 mile search radius. Four (4) are within the project area. A Waters of the US Report is recommended and coordination with the appropriate agency, if applicable, will occur.

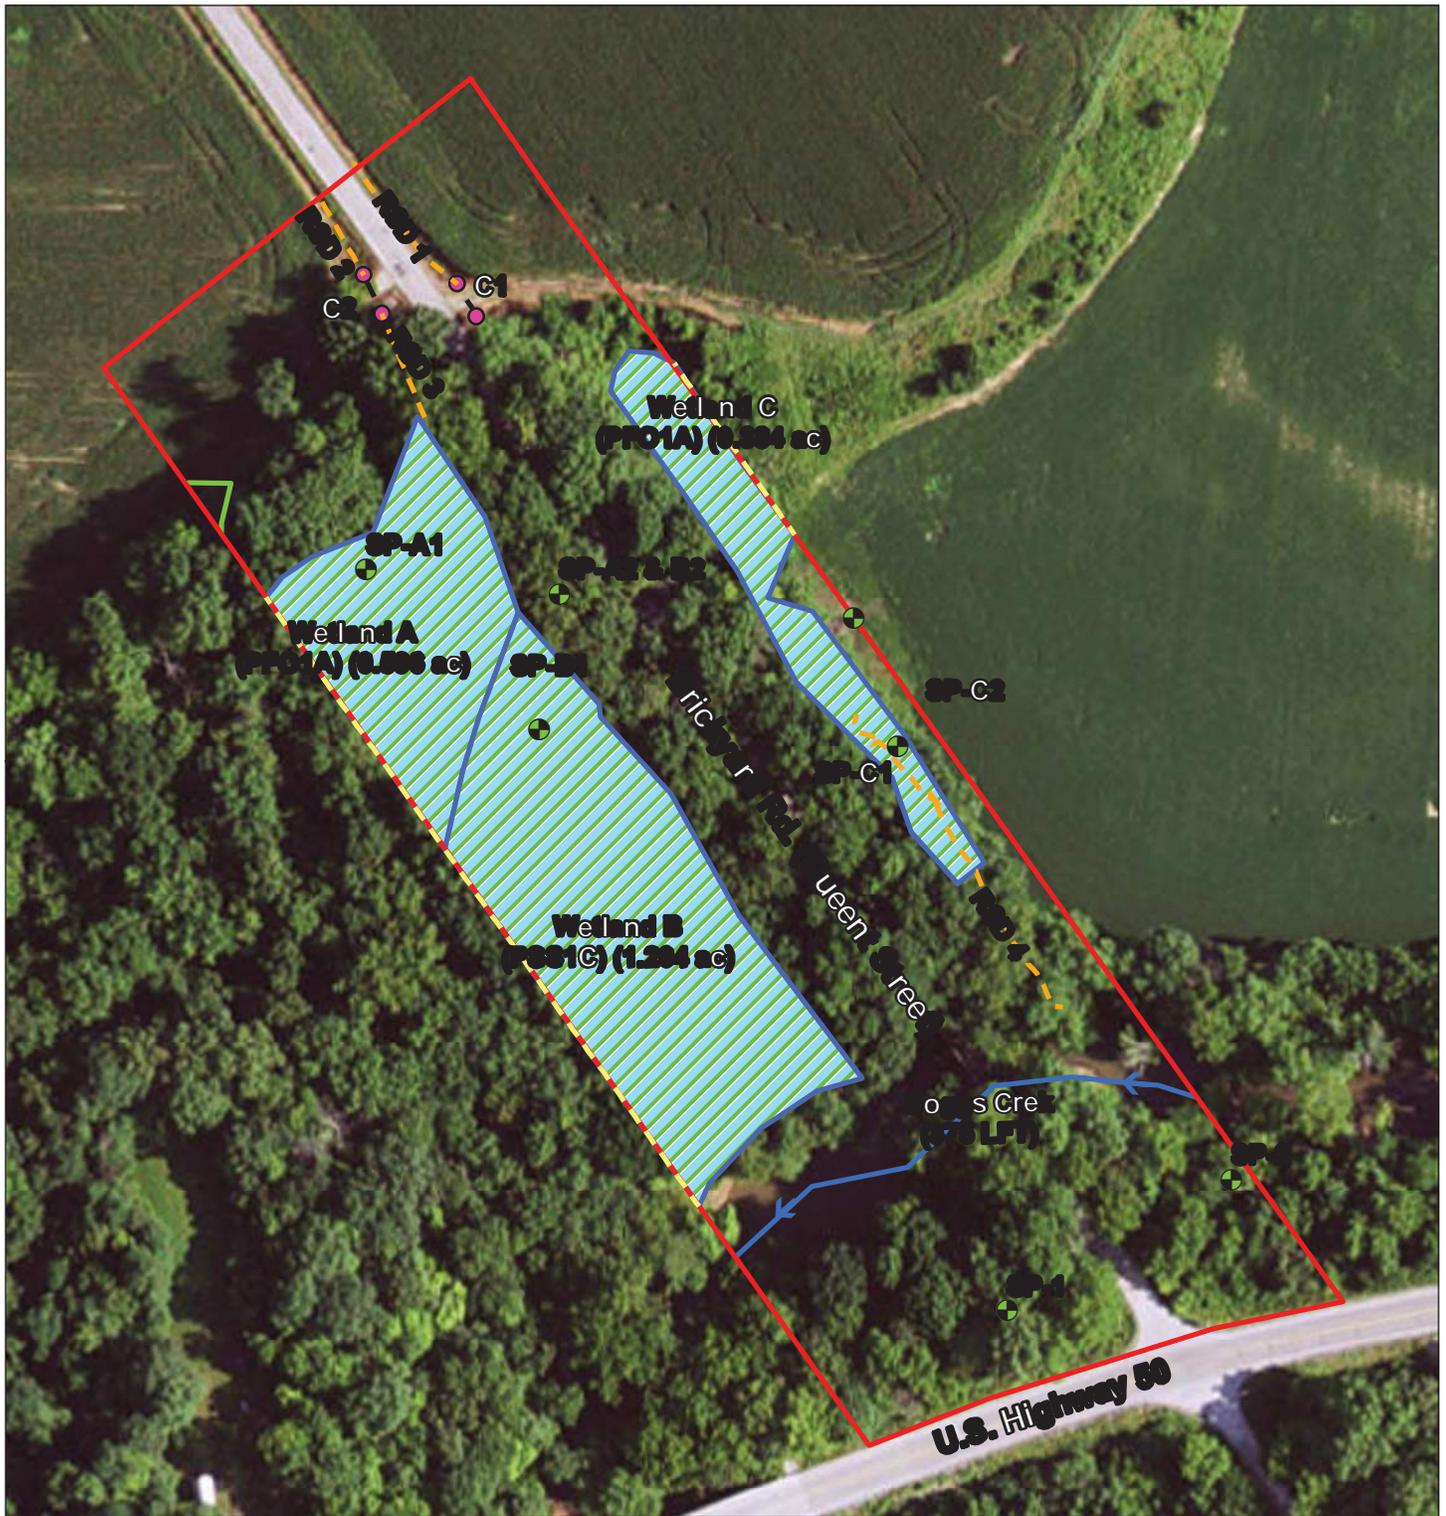
Exh. 6

| Project Study Limits (PSL) | Stream | Roadside Ditch (RSD) |

Exhibit 6 - Waters Delineation Map  
 Brickyard Road Over Boggs Creek  
 Bridge Replacement  
 Perry Township, Martin County, Indiana  
 Des. No. 1902785  
 Metric Project No. 20-0077  
 Map Date: 10/2/2020  
 Map Author: Zachary Root

One stream, Unnamed Tributary (UNT) 1, was observed within the PSL during the field reconnaissance. A description of the stream is provided in Table 5 below.

Four roadside ditches (RSD) were identified within the PSL. These features consisted of riprap and vegetated drainage swales consisting of field brome (*Bromus arvensis*, FACU) and black walnut (*Juglans nigra*, FACU). No OHWM was observed in these features, so they are likely non-jurisdictional.

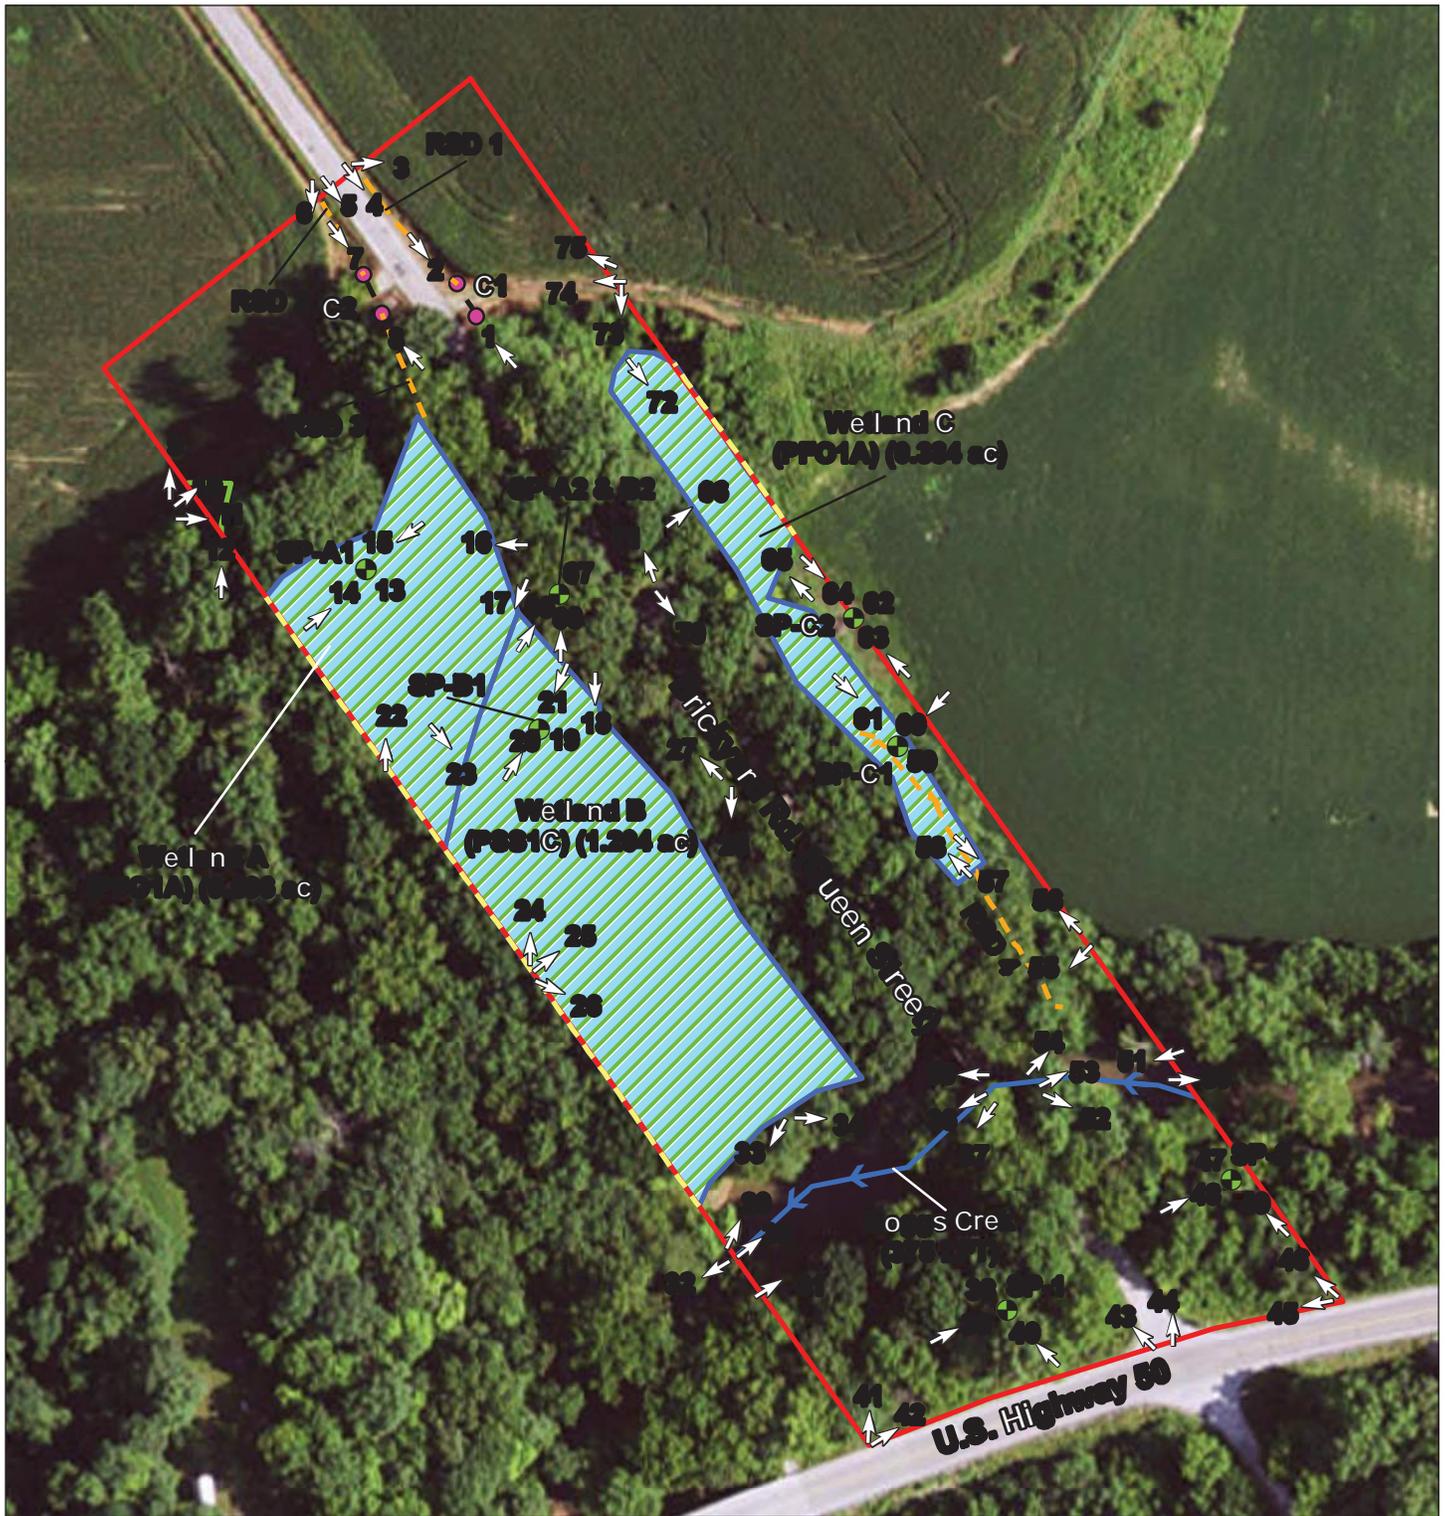
Exh. 7

Exhibit 7 - Photograph Location Map  
 Brickyard Road Over Boggs Creek  
 Bridge Replacement  
 Perry Township, Martin County, Indiana  
 Des. No. 1902785  
 Metric Project No. 20-0077  
 Map Date: 10/2/2020  
 Map Author: Zachary Root

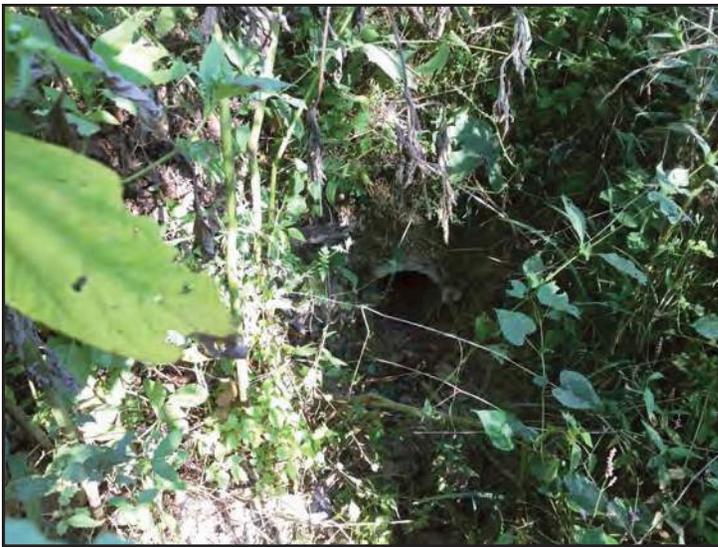
1. View of Culvert (C) 1 - outlet, looking northwest.

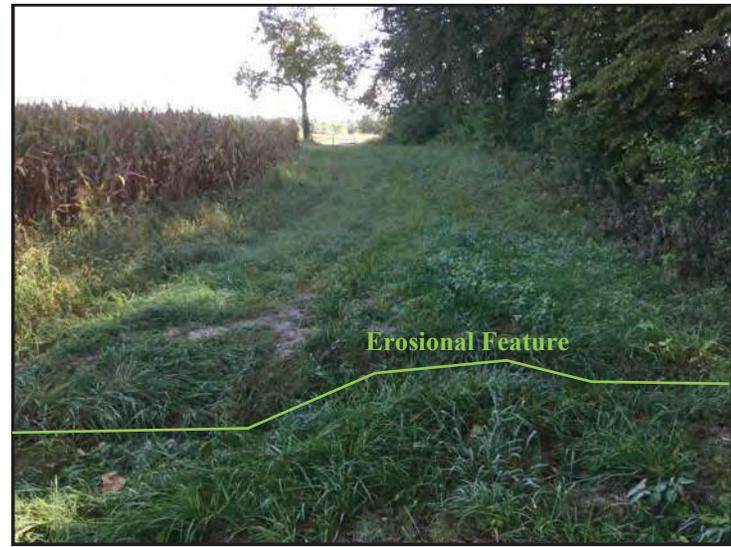
10. View of erosional feature, looking northeast.

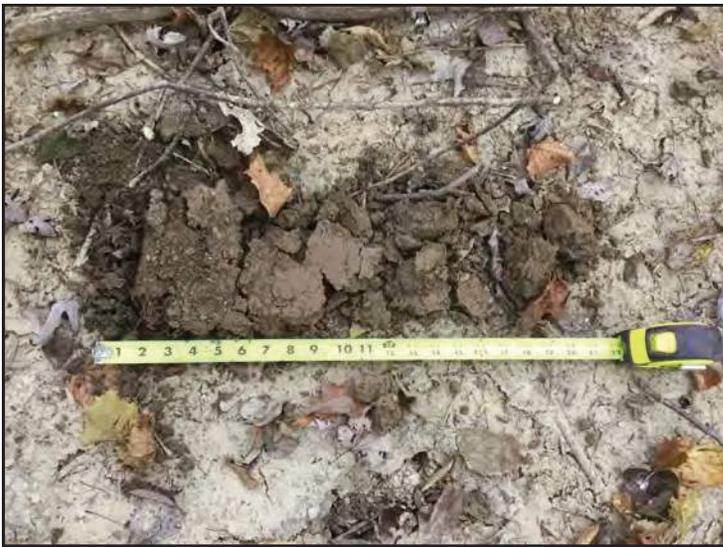
13. View of SP-A1, Wetland A Sampling Point, soil profile.

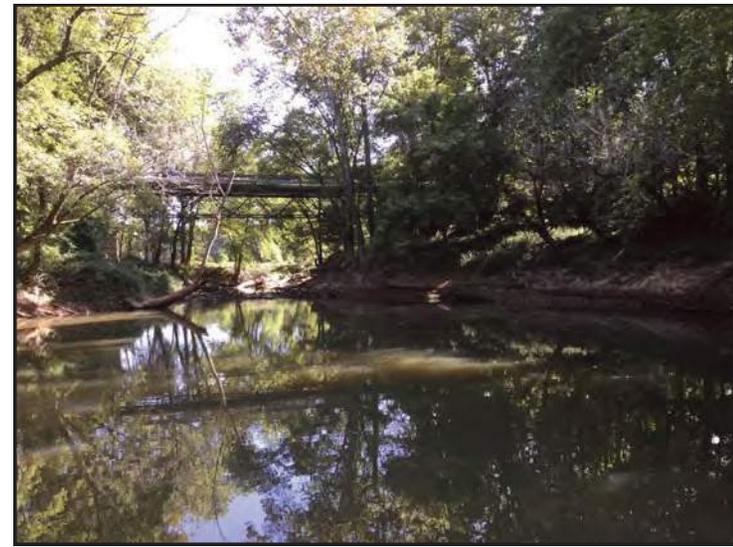
30. View of Boggs Creek from the southwestern PSL, looking northeast (upstream).

Riverine, Unknown Perennial, Unconsolidated Bottom, Permanently Flooded (R5UBH) NWI polygon. Since Boggs Creek is a perennial stream, exhibiting connection to a TNW, it should be considered a jurisdictional Water of the U.S. The ordinary high water mark (OHWM) was 68 ft. wide and 6 ft. deep within the PSL. Measurements of the OHWM were taken outside the influence of the structure. The dominant stream substrate was cobble and gravel. Functional riffles and pools were observed within the stream. Moderate to extensive amounts of instream cover was observed, which included overhanging vegetation, woody debris, and undercut banks. Moderate sinuosity and moderate current velocity were observed. Streambanks exhibited little erosion and the floodplain area was composed of deciduous forest on both sides of the stream. Fish and macroinvertebrates were observed within the stream during the field reconnaissance. Vegetation observed along the streambanks included common button bush (*Cephalanthus occidentalis*, OBL), American elm (*Ulmus americana*, FACW), and Virginia wild rye (*Elymus virginicus*, FACW). According to USGS *Indiana StreamStats*, the drainage area upstream of Boggs Creek at the PSL is 85.997 square miles. Qualities of the stream listed above contribute to Boggs Creek being classified as average quality.

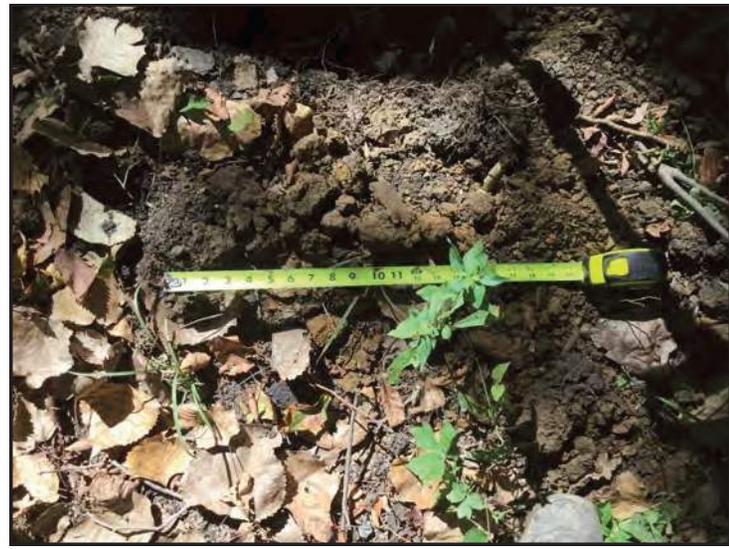
38. View of SP-1, Sampling Point 1, soil profile.

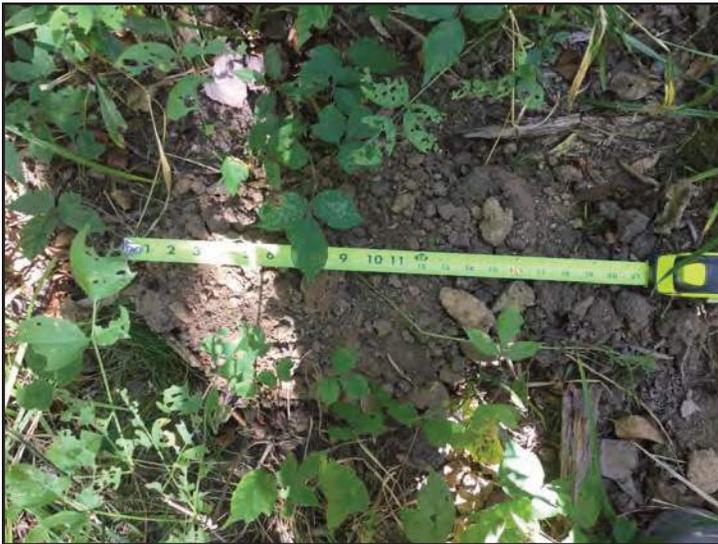
47. View of SP-2, Sampling Point 2, soil profiled.

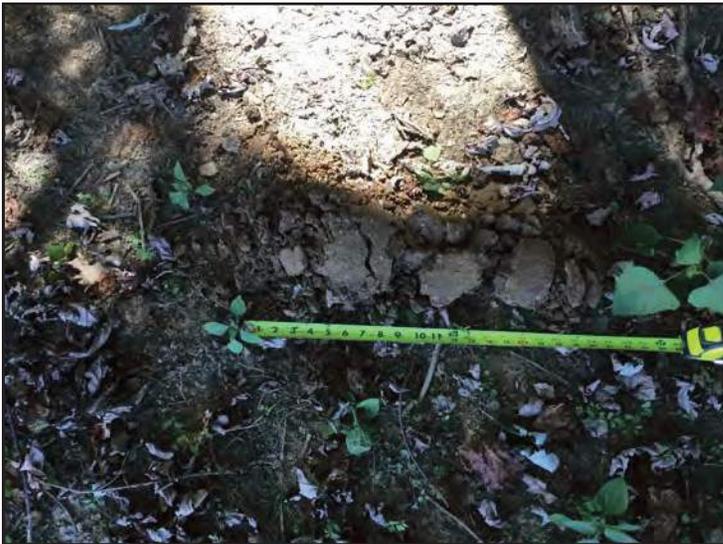
59. View of SP-C1, Wetland C Sampling Point, soil profile.
